NASA Contractor Report 191468

**SPACE ENVIRONMENTAL EFFECTS ON THE
INTEGRITY OF CHROMIC ACID ANODIZED
COATINGS**

**BOEING DEFENSE & SPACE GROUP
Seattle, Washington**

Contracts NAS1-18224 and NAS1-19247
May 1993

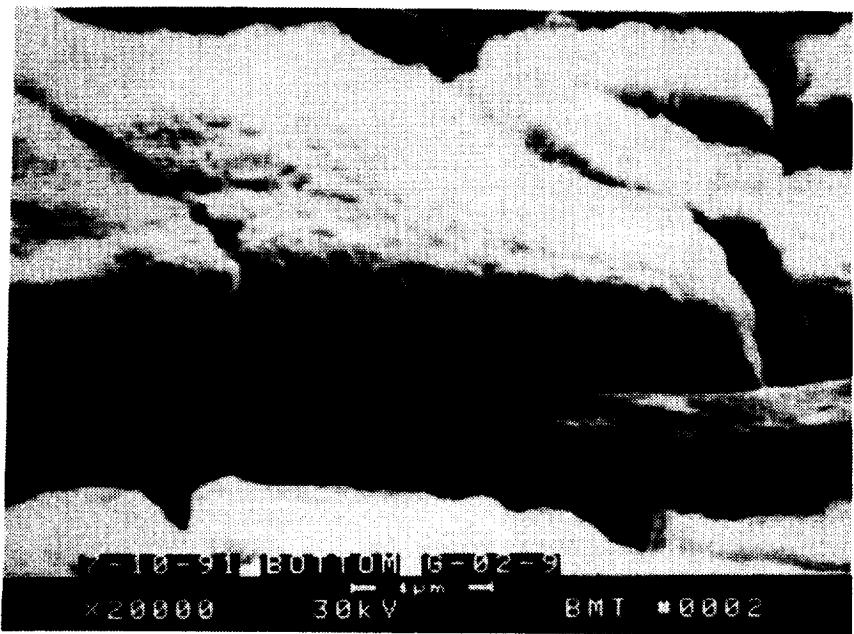
FIGURE 3. Typical SEM photomicrographs showing anodize coating thickness

SEM analysis was employed to measure the anodize coating thickness on the tray clamps. Small specimens cut from the clamps were fractured and photomicrographs were obtained of the fracture surfaces from both the front and back of the clamps. The coating thicknesses were then measured directly from the photomicrographs. The back side of each clamp acted as a control and the data was evaluated to determine if space exposure had any effect on the coating thickness. Typical photomicrographs showing the anodize coating are presented in Figure 3. All of the photomicrographs evaluated are included in appendix B.
